## **MICROLEAKAGE AROUND CLASS V RESTORATIONS AFTER ULTRASONIC SCALING: A COMPARATIVE STUDY**

*Department of Conservative Dentistry  
Belarusian State Medical University, Minsk*

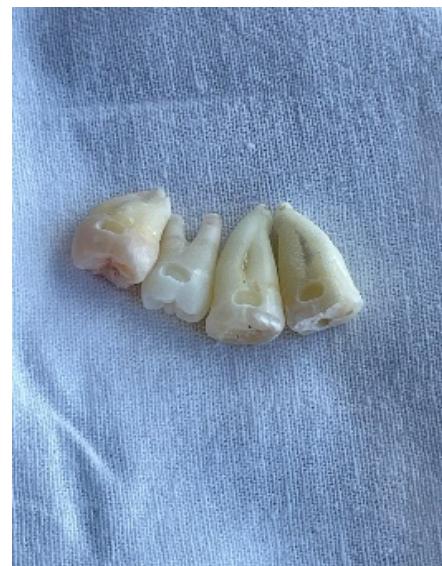
**Fig. 1** – Prepared teeth

**Materials and methods.** 32 Extracted teeth with class V cavities were selected for the stud (img. 1), prepared with diamond and carbine burs, turbine ana angle handpiece, etched and bonded (img. 2). Each 4 samples were filled with one of the filling materials showed in (img. 3), polished with rubber cups and polishing discs (img. 4). Teeth were marked before any manipulation and pictures were taken, subjected to a load of ultrasonic scaling (30 sec) and aggressive scaling while a caries marker was used after each process. The samples were photographed with a macro lens camera for further visual evaluation of the results.

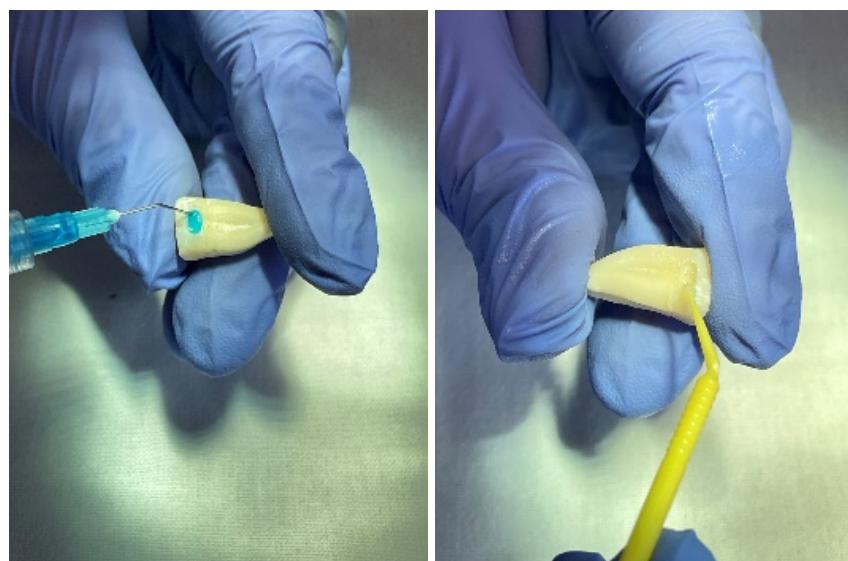
**Fig. 2** – Etching and bonding

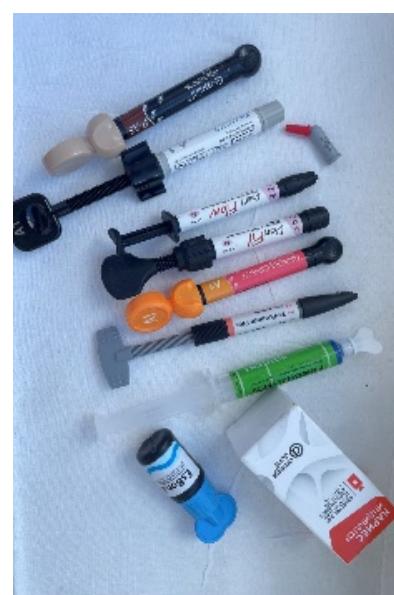
**Fig. 3** – Materials used

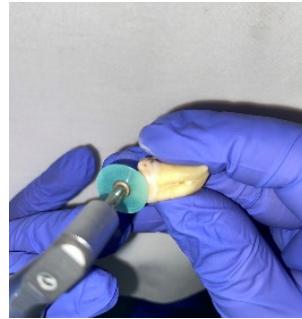
**Fig. 4 – Finishing and polishing**

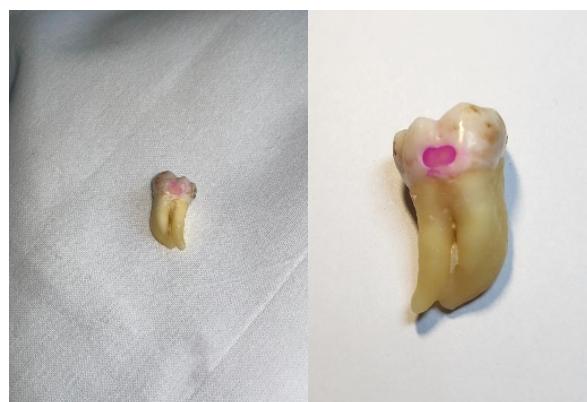
**Fig. 5 – GIC vitremer**

50% GIC Vitremer (img. 5);

30% GIC vitremer;

Gradia GC, Bulk SDR+ (img. 7) and Denfil (img. 10) have the greatest tolerance under excessive force, minimal microleakage. GIC vitremer has Minimal tolerance and great risk of microleakage. Gaenial, EsCom 250 & T econom+ have Moderate tolerance, presence of risk of microcracks.

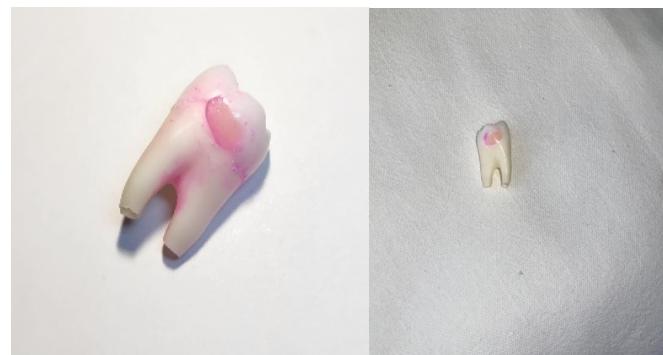
**Fig. 6 – Geanial**

16.6% Gaenial, Escom 250 & T econom plus (img. 6);

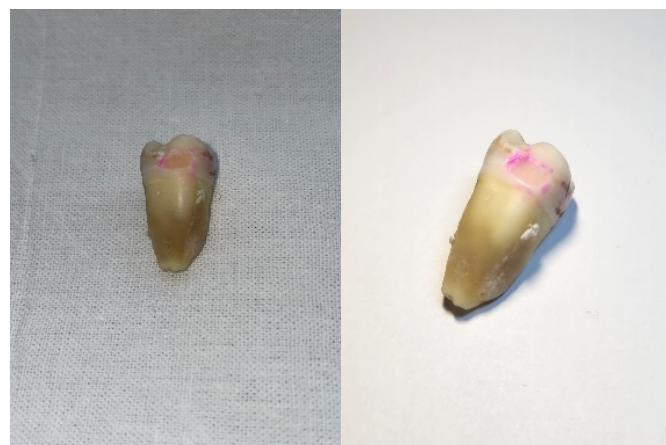
**Fig. 8 – T econom+**

15.3%T econom plus (img. 8) and Escom 250 (img. 9).
